### Preventing infection in MRI: Best practices for infection control in and around MRI suites, part II

By [Dr. Peter A. Rothschild](#)

June 27, 2008

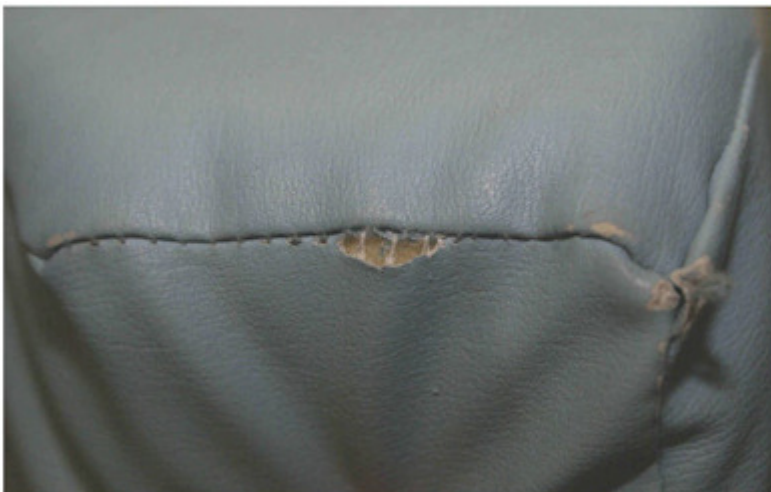
In the late 1980s and early 1990s when many of the pad systems in use today were developed, they were not designed to take the wear and tear of 5,000 to 10,000 patients a year for so many years. The fabric covers were coated with some type of plastic to make it waterproof. However, this plastic wears off, especially with cleaning solutions and with use. As a result, pad coverings have worn out, exposing the foam core, or have lost their ability to prevent penetration of bacteria and fluids into the central core, where it is impossible to clean.

*Torn and frayed table pad. Image courtesy of Dr. Peter A. Rothschild.*

One much overlooked concern is the torn and frayed pads used in imaging departments and centers. Once the covering material has been breached, pads cannot be properly cleaned and should be immediately removed and replaced. This was clearly demonstrated by Shigeharu Oie, Ph.D., and colleagues from Yamaguchi University Hospital in Ube, Japan. In their article, "Contamination of Environmental Surfaces by *Staphylococcus aureus* in a Dermatological Ward and Its Preventive Measures," they stated, "Items with a smooth surface can be repeatedly used without problems if disinfected. However, on items with a porous surface made of a spongy material, *S. aureus* was detected even after disinfection had been done. Thus, porous surfaces made of such material cannot be adequately disinfected" (*Biological and Pharmaceutical Bulletin*, 2005, Vol. 28:1, pp. 120-123).

Only in the last five to 10 years have hospital-acquired infections become so significant. Before that time, there was very little concern for contamination, and MRSA was not as prevalent as today. Therefore, pads on most imaging tables do not incorporate newer technologies developed to assist in infection control. Permanent antimicrobial agents should be incorporated into all table pads and positioners, as well as scanner controls, keyboards, etc. For added protection, the seams of the table pads should not only be tightly sewn, but also welded closed or have another permanent barrier in place in addition to simple stitching. The integrity of these seams is crucial in protecting patients.

Another area of concern is that of aerosolization of MRSA bacteria. Table pads inherently have air within them. When a patient lies down on the pads, this air is forced out through any hole or seam in the covering materials. This can cause the bacteria contaminating the central foam core to become ejected from the pad and aerosolized into the room environment. Of course, the reverse airflow caused by the patient rising off the pads causes infectious materials to be drawn into the foam core from the surface, which is then re-ejected into the air when the next patient lies on the pad.

This is clearly another reason why all pads must be inspected with a magnifying glass, and if any holes or loss of integrity of the covering material in any way is detected, the pads must be replaced.
